**TOWN OF HEBRON
CAPITAL IMPROVEMENT PROGRAM
FY 2024-2025
TOWN MANAGER PROPOSED
MARCH 1, 2024**

**FY 2024-2025
CIP Budget Revenue
Town Manager Proposed March 1, 2024**

**CAPITAL IMPROVEMENT PROGRAM
FIVE YEAR PLAN**

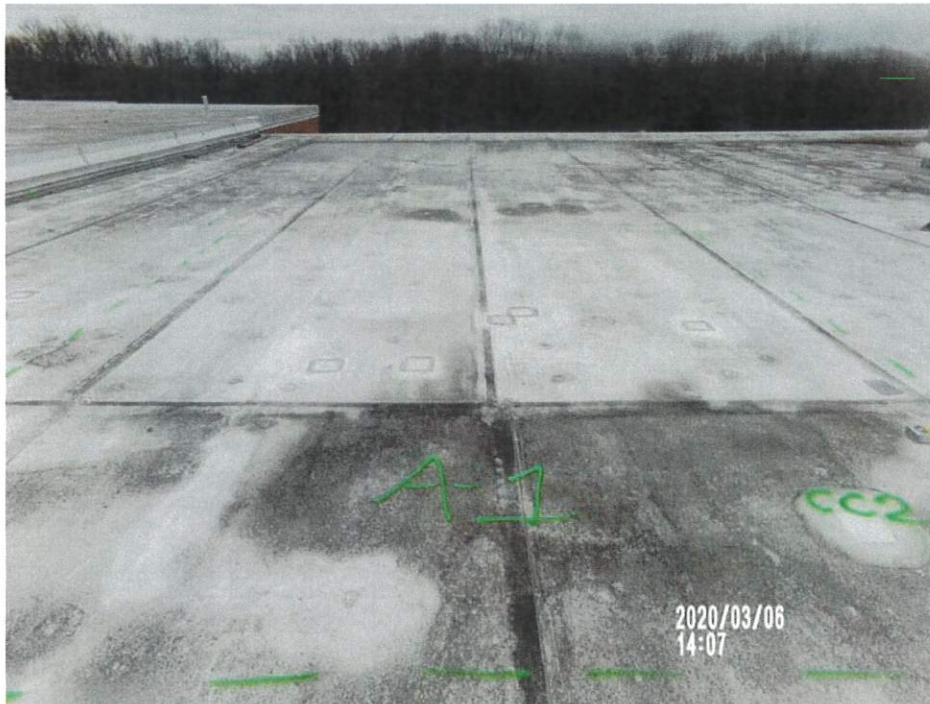
- Three (3) suspected wet areas were found on this roof section.
 - Three (3) core cuts were taken on this roof section.
 - #CCA1 (Dry)
 - PVC
 - 1.5" Polyisocyanurate (0%)
 - 1.5" Polyisocyanurate (0%)
 - Metal Deck
 - #CCA2-Wet area #A1. (Wet)
 - PVC
 - 1.5" Polyisocyanurate (Top: 60%; Bottom: 75%)
 - 1.5" Polyisocyanurate (0%)
 - Metal Deck
 - #CCA3-Wet area #A1. (Wet)
 - PVC
 - 1.5" Polyisocyanurate (Top: 25%; Bottom: 2.7%)
 - 1.5" Polyisocyanurate (0%)
 - Metal Deck

Roof A-Wet area A-1, looking East

1. Remove & Replace 1,073 square feet of wet insulation found during the thermal scan located on roof levels A, C, & E returning overall roofing system observed to a dry condition.
2. Consider adding tapered crickets & saddles to all identified ponding areas to promote positive drainage (5,400 square feet of ponding area)
3. Consider adding additional drains to assist positive drainage of ponding water conditions (roof A)
4. Consider cleaning the roofing membrane of all roof contaminants using RoofTec Cleaning program (EPA compliant roof cleaning program, <https://www.rooftecsystems.net/>)

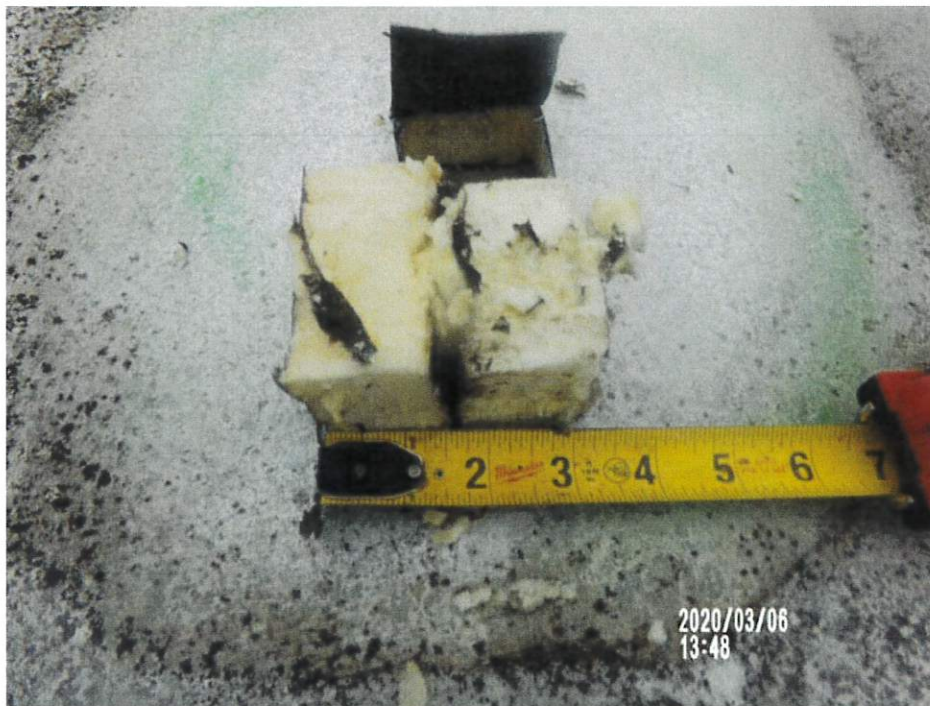
Roof A-Core cut #CC2 at wet area #A1 (Wet)

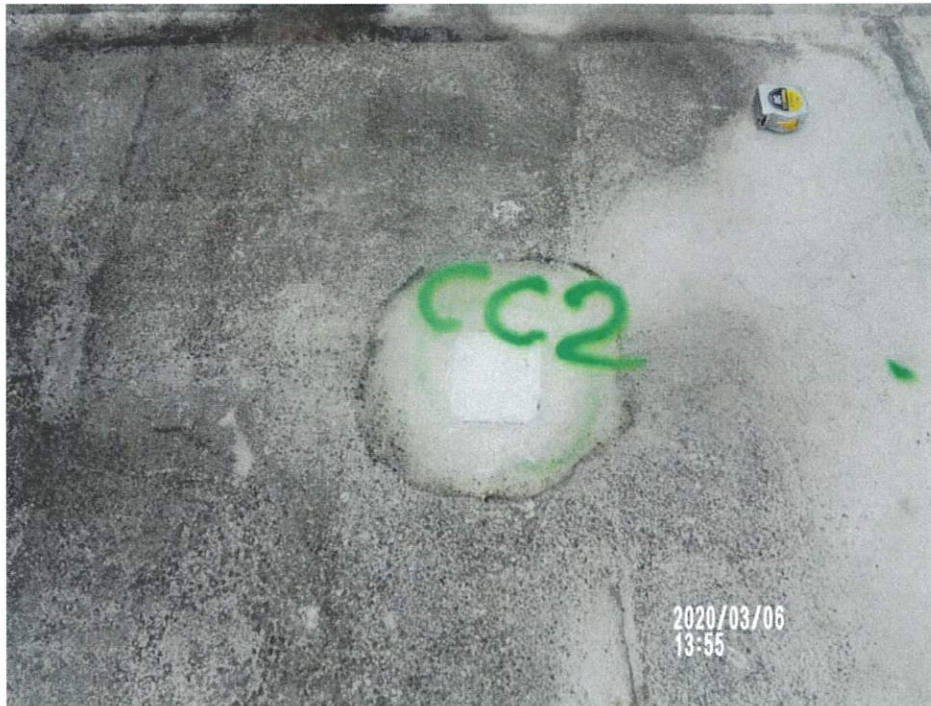
Roof A-Core cut #CC2 repaired, looking East

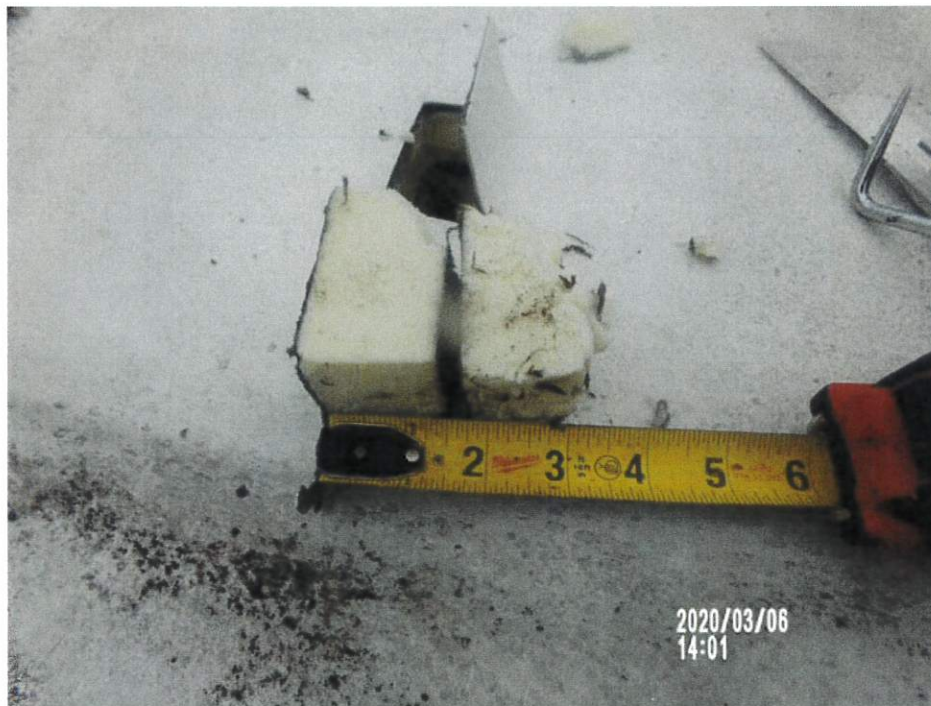
Roof A-Core cut #CC3 at wet area #A1 (Wet)

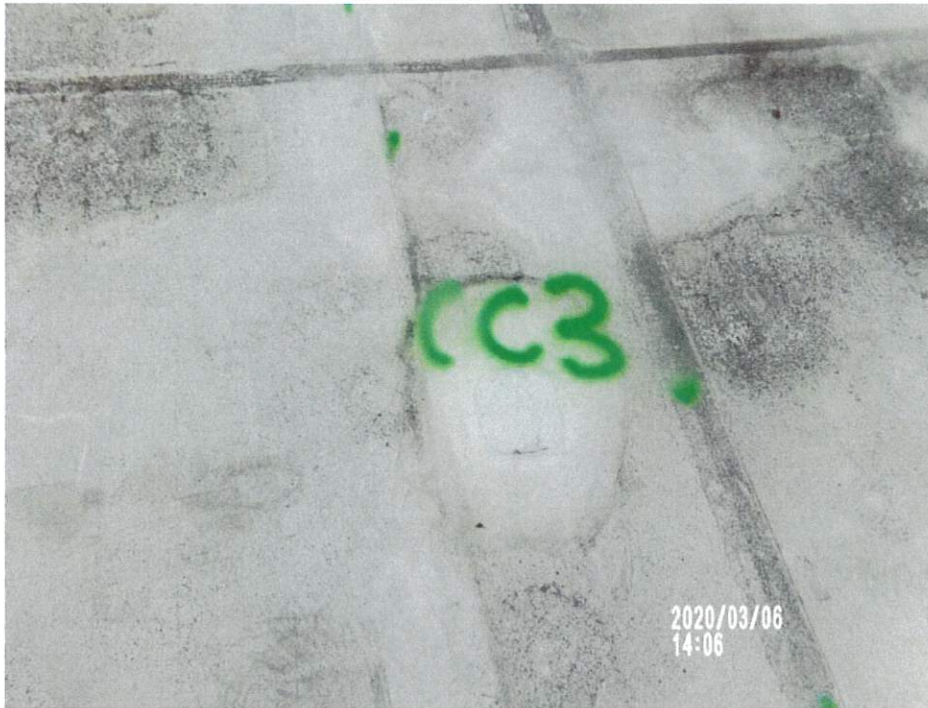
Roof A-Core cut #CC3 repaired, looking East

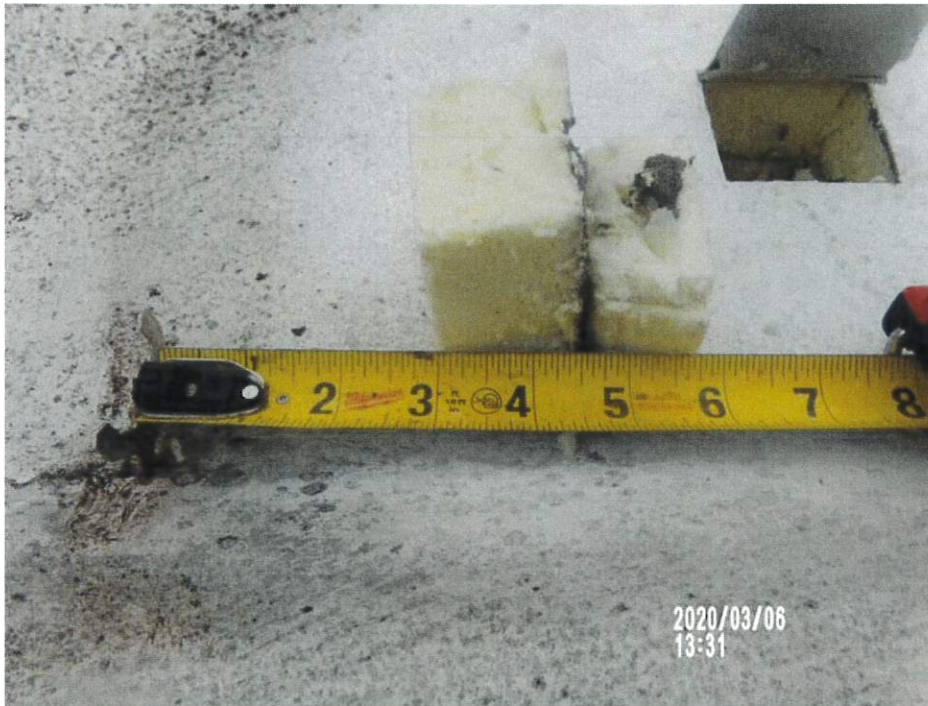
Roof A-Core cut #CC1 (Dry)

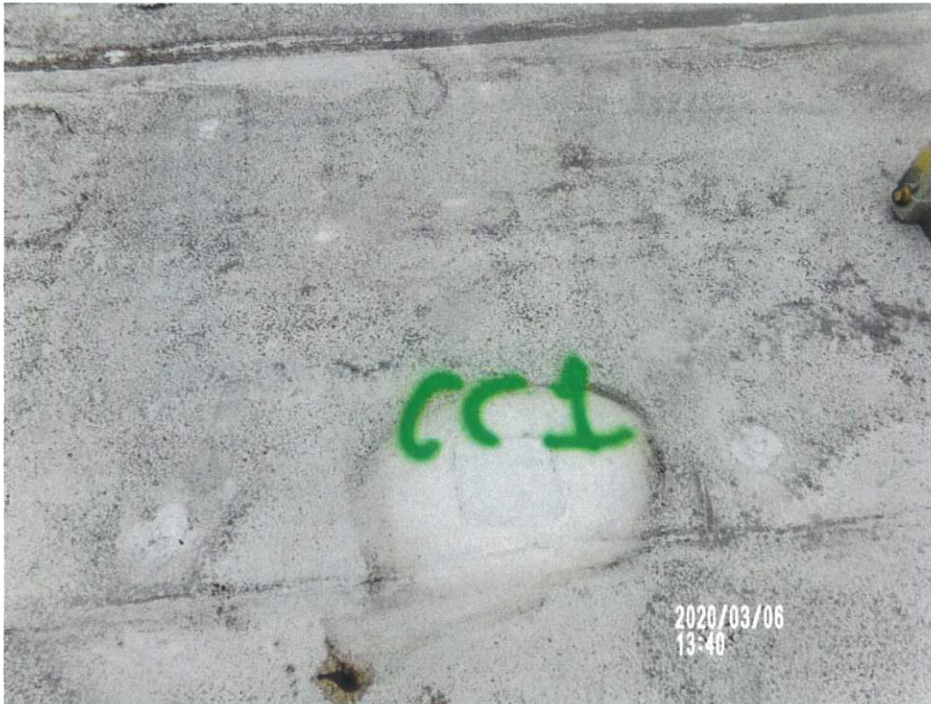
Roof A-Core cut #CC1 repaired, looking East

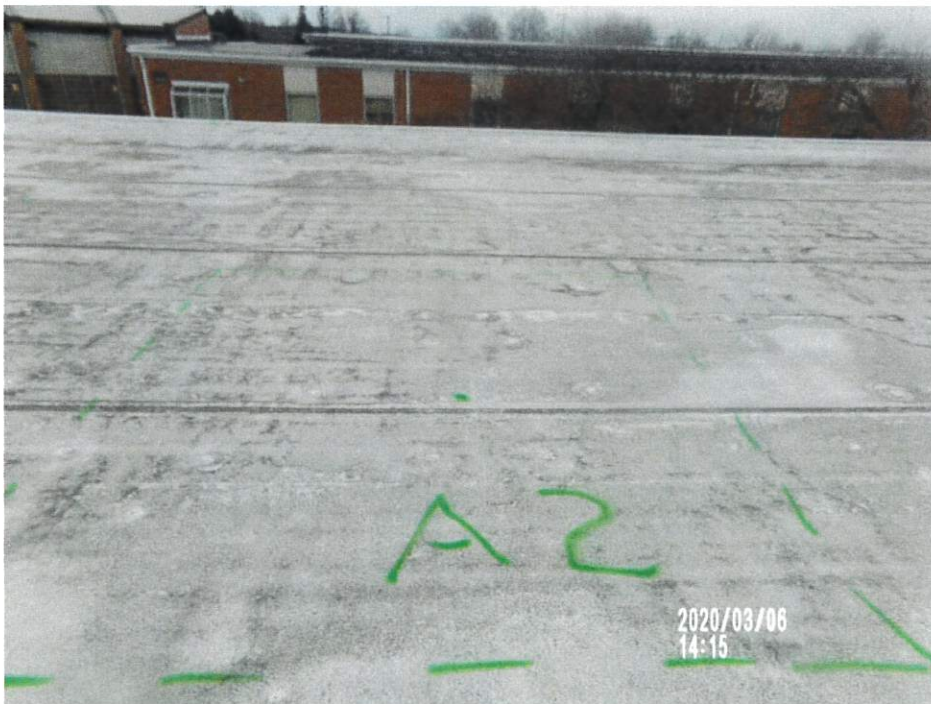
Roof A-Suspected wet area A-2, looking South

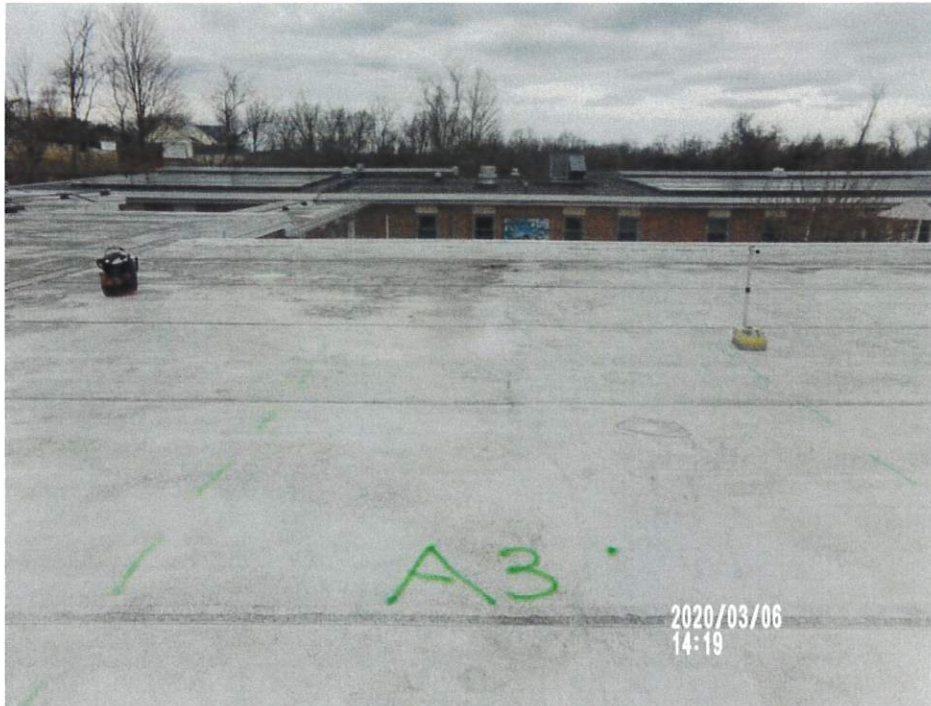
Roof A-Suspected wet area A-3, center, looking North

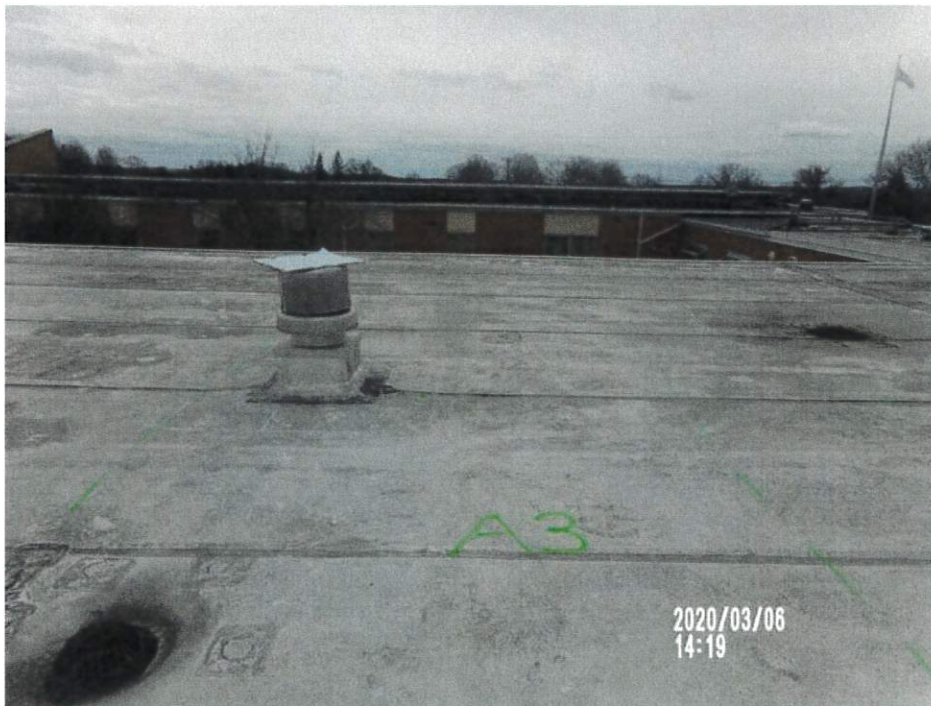
Roof A-Suspected wet area A-3, center, looking South

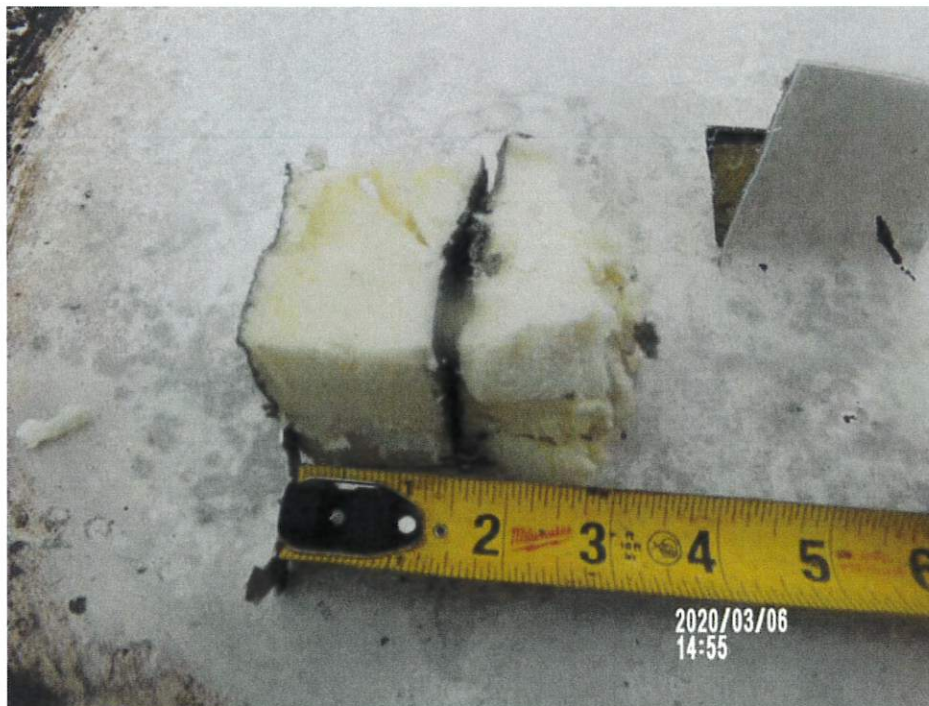
- No suspected wet areas were found on this roof section.
 - One (1) core cut was taken on this roof section.
 - #CCB1 (Dry)
 - PVC
 - 1.5" Polyisocyanurate (0%)
 - 1.5" Polyisocyanurate (0%)
 - Metal Deck

Roof B-Core cut #CCB1 (Dry)

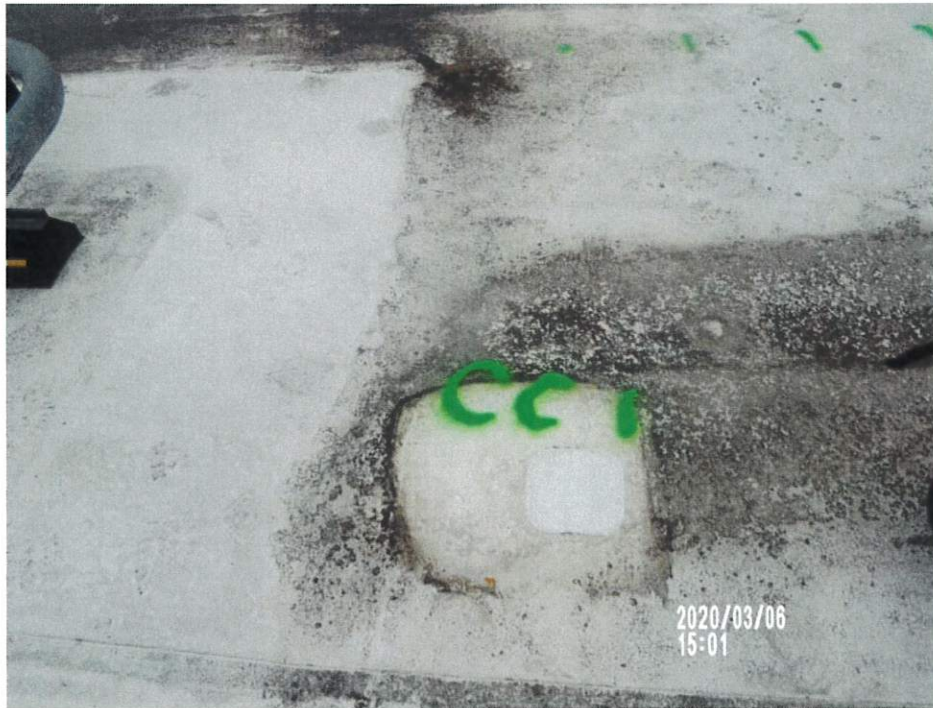
Roof B-Core cut #CCB1 repaired, looking East

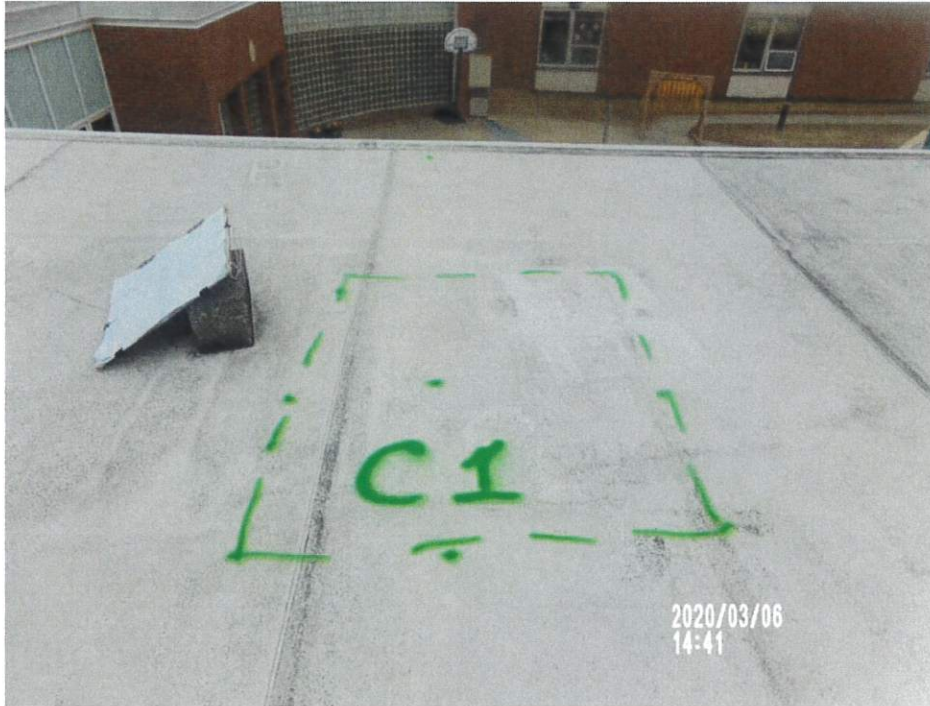
Roof C-Suspected wet area C-1, looking South

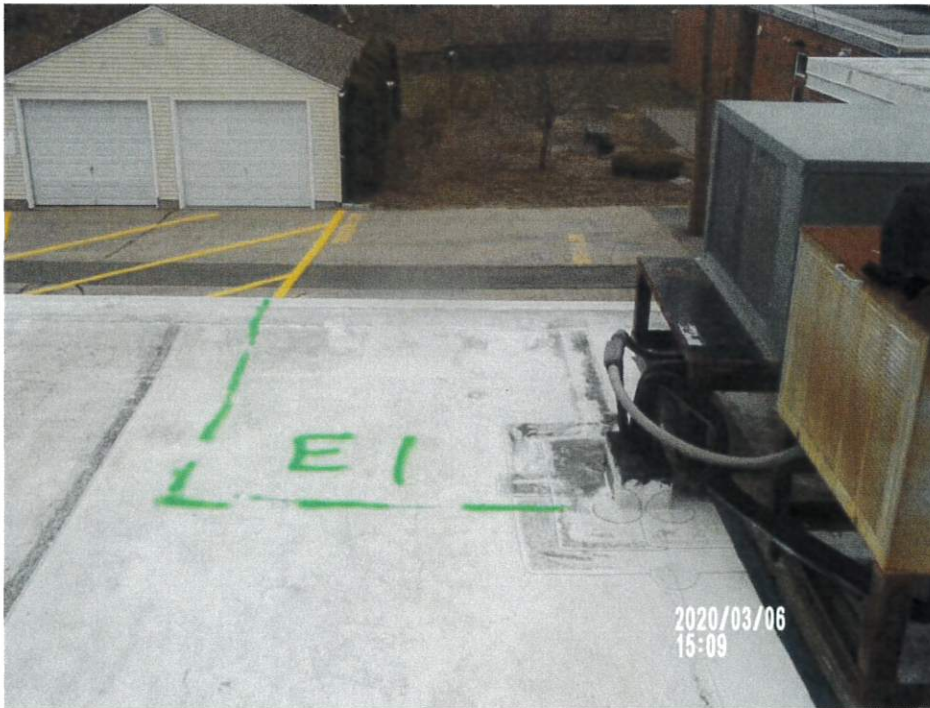
Roof E-Suspected wet area E-1, West side, looking North

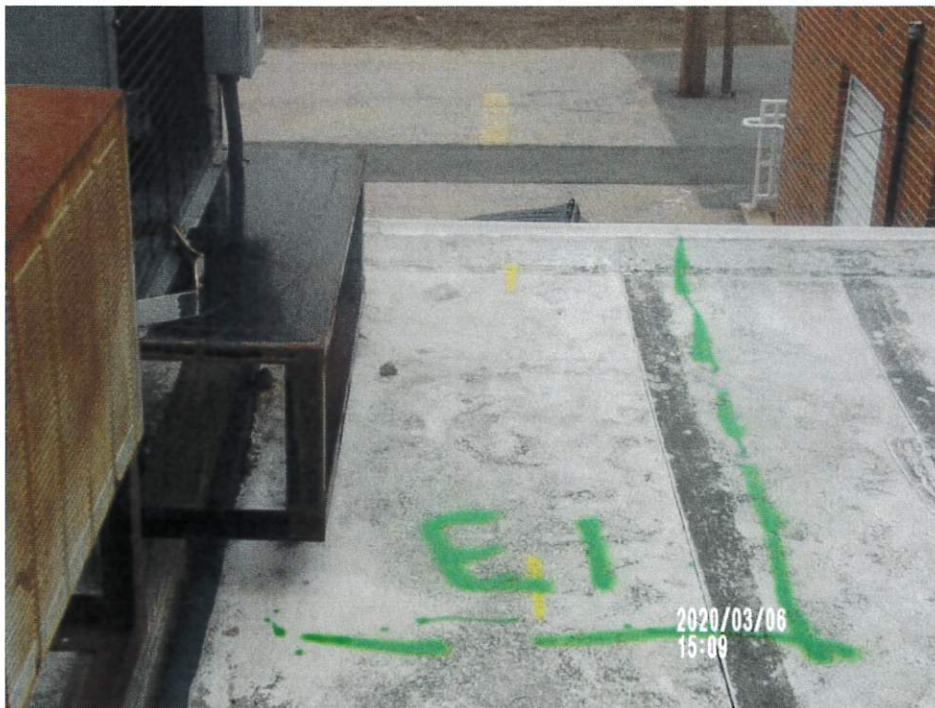
Roof E-Suspected wet area E-1, East side, looking North

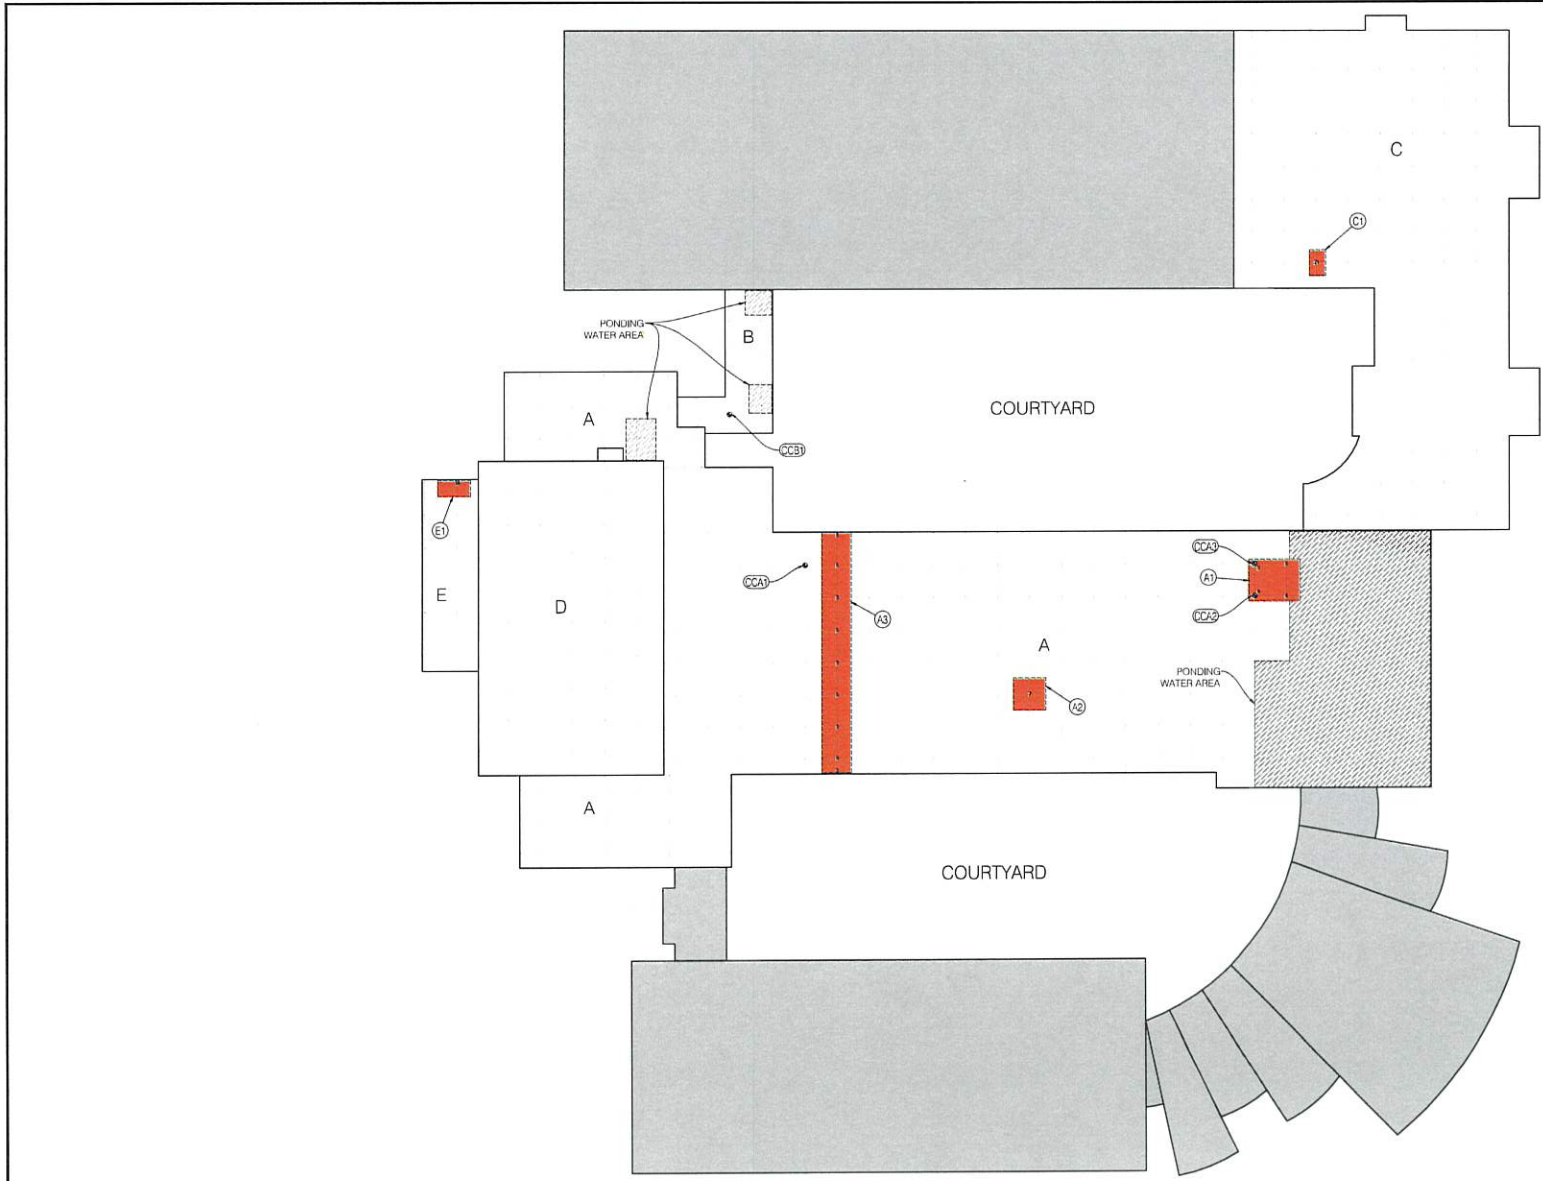
BUILDING ROOF - MOISTURE SCAN

'A' TOTAL SUSPECTED WET SQ FT = 983				
AREA#	SIZE	SO FT	NOTES	
A1	16 x 13	208	CCA2, CCA3	
A2	10 x 10	100		
A3	9 x 75	675		
'C' TOTAL SUSPECTED WET SQ FT = 40				
AREA#	SIZE	SO FT	NOTES	
C1	5 x 8	40		
'E' TOTAL SUSPECTED WET SQ FT = 50				
AREA#	SIZE	SO FT	NOTES	
E1	10 x 5	50

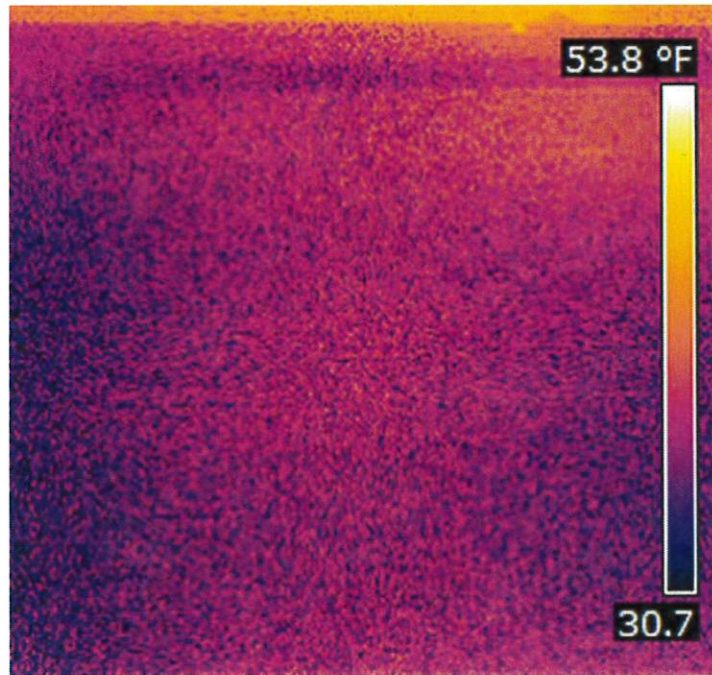
Roof A-No suspected wet areas identified or recorded on this roof section.

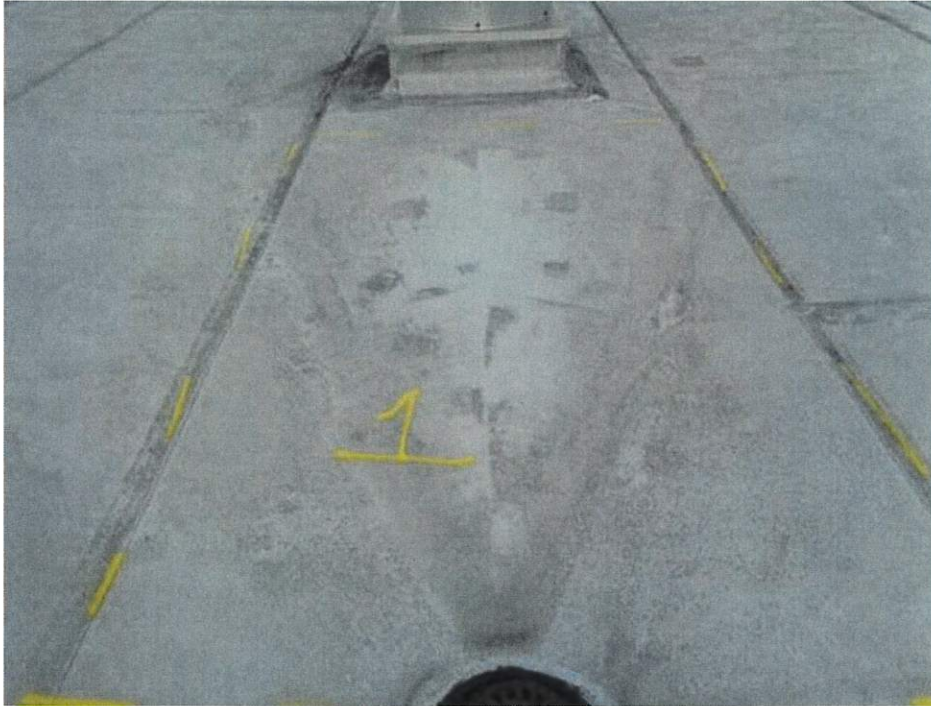
- One (1) wet area was found on this roof section.
 - One (1) core cut was taken at wet area #B1.
 - #CC1 (Wet)
 - TPO
 - 1.5" Polyisocyanurate (Top: 70%; Bottom: 67%)
 - ½" Polyisocyanurate (Top: 78%; Bottom: 77%)
 - 3" Polyisocyanurate (Top: 72%; Bottom: 0%)
 - Metal Deck

Roof B-Wet area #1, looking East

1. Remove & Replace 100 square feet of wet insulation found during the thermal scan located on roof level B returning overall roofing system observed to a dry condition.
2. Consider cleaning the roofing membrane of all roof contaminants using RoofTec Cleaning program (EPA compliant roof cleaning program, <https://www.rooftecsystems.net/>)

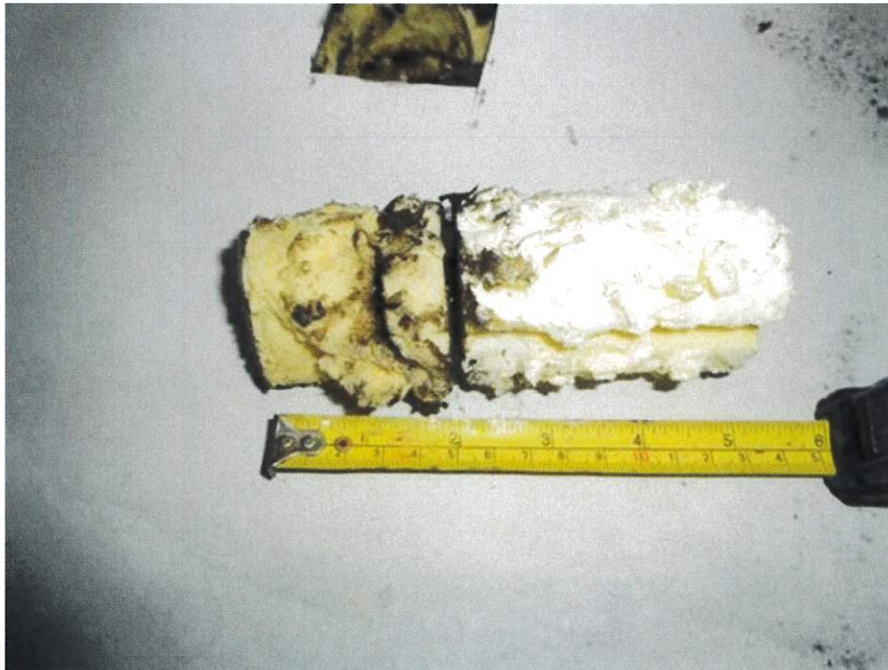
Core Cut #CC1-TPO, 1 1/2" Polyisocyanurate, 1/2" Polyisocyanurate, 3" Polyisocyanurate and a metal deck. (Wet)

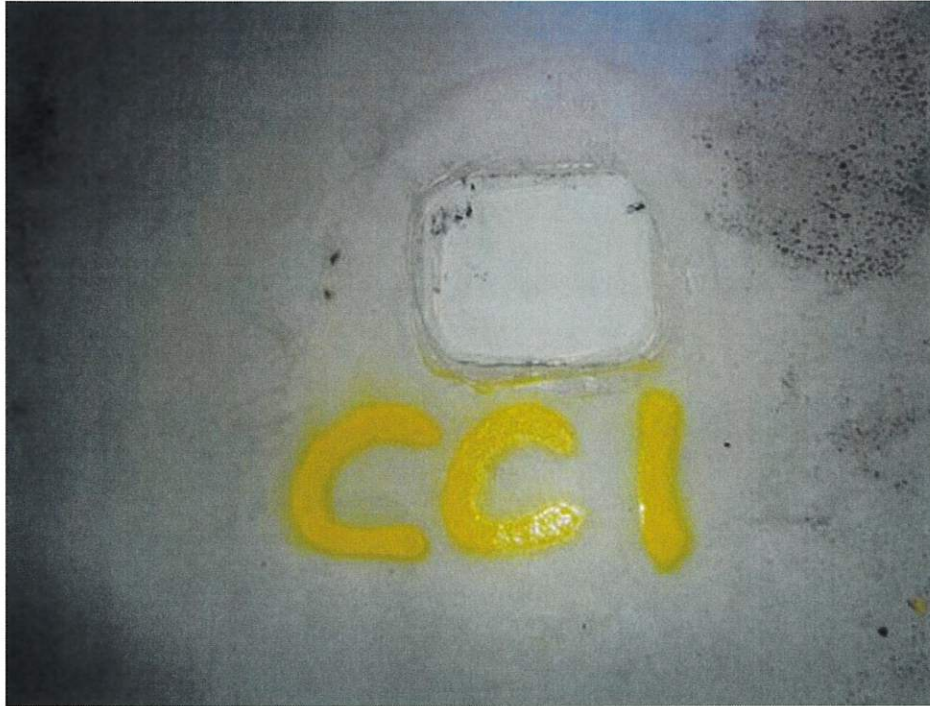
Core Cut #CC1 repaired

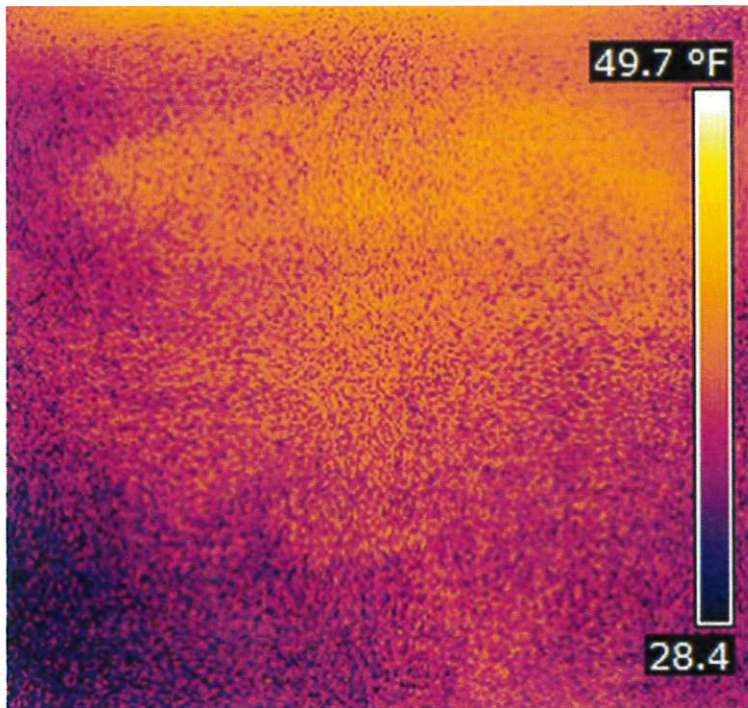
Wet area #1

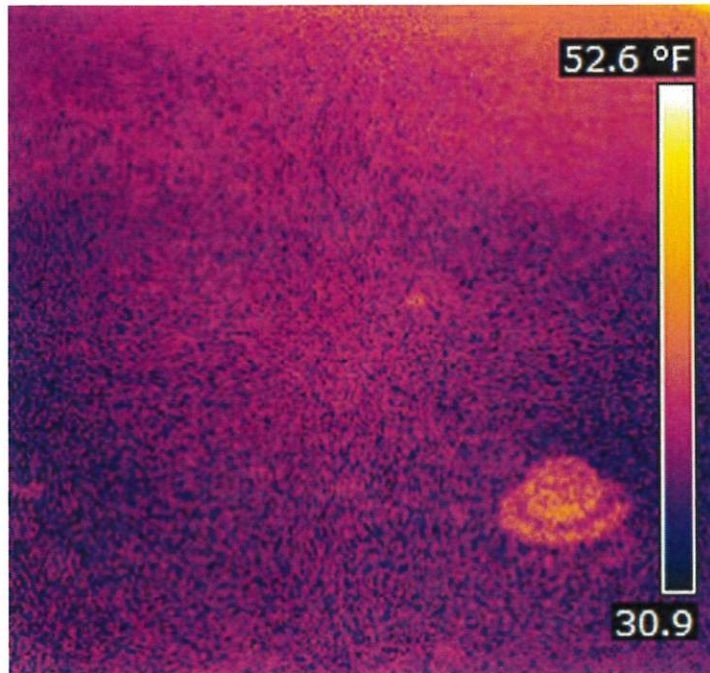
Roof C-No suspected wet areas identified or recorded on this roof section.

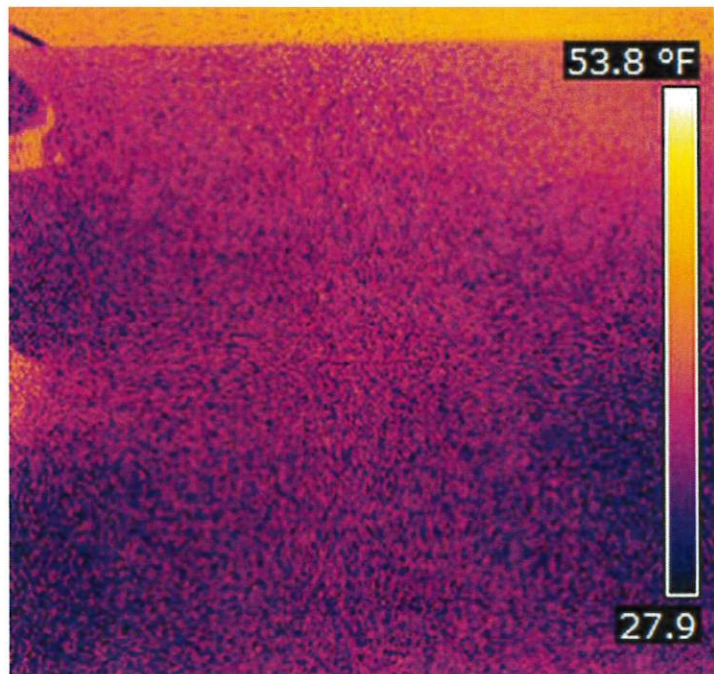
Roof D-No suspected wet areas identified or recorded on this roof section.

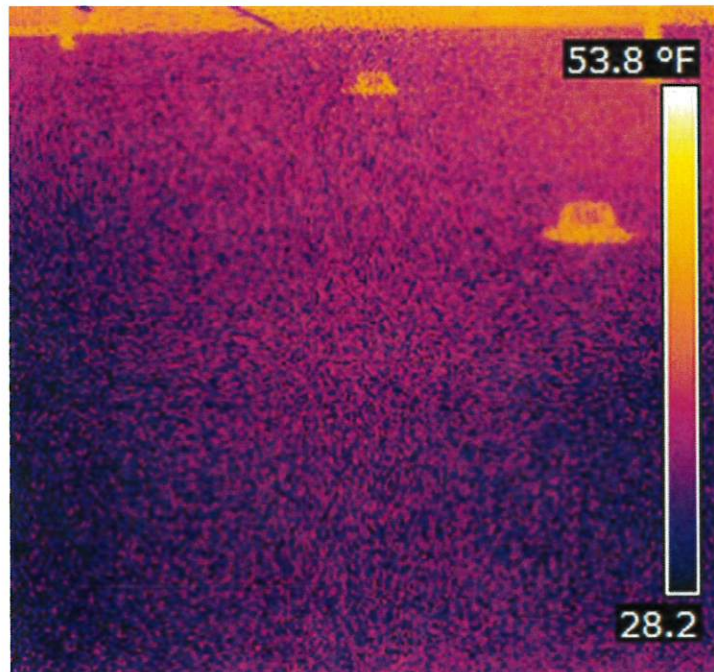
Roof E-No suspected wet areas identified or recorded on this roof section.

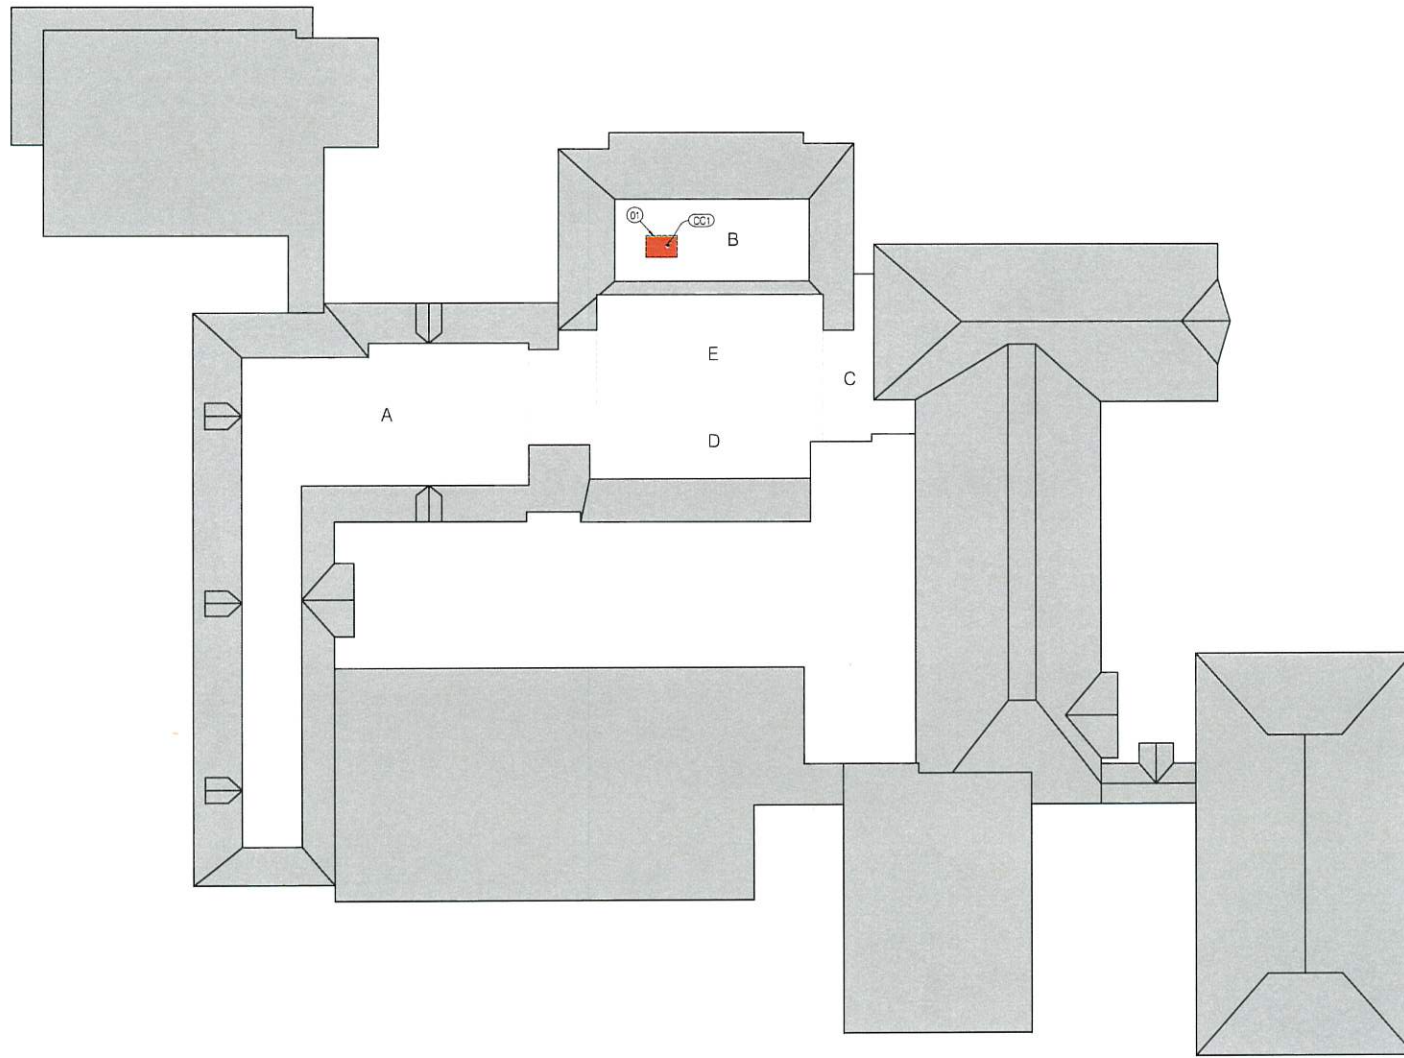
BUILDING ROOF - MOISTURE SCAN

'B' TOTAL SUSPECTED WET SQ FT = 70

AREA#	SIZE	SQ FT	NOTES
01	10 x 7	70	CC1
