**TOWN OF HEBRON
MUNICIPAL FACILITIES STUDY**

**FINAL DRAFT
JUNE 24, 2010**

Executive Summary

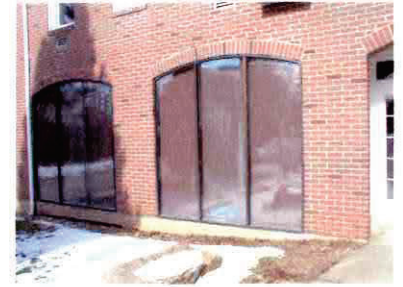
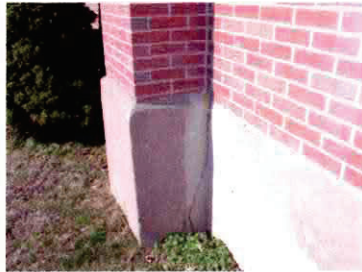
It has been observed when it is raining, water from the roof overflows the gutter and is creating a trough on the ground along the building. This is caused by debris in the gutters and downspouts being clogged. The debris is mainly caused by leaves from the trees to the West. To prevent further ground erosion, maintenance costs and to extend the life of the roof, gutter guards should be installed. This will allow debris to fall off of the roof and reduce the maintenance cost associated with cleaning the gutters and repairing the ground.

The concrete foundation wall on the original building has been repaired over the years. The outside corners of the foundation have spalling concrete and the chimney has separated from the building. The cause of the cracking is not known and this condition should be monitored to determine if it is still moving or the separation was a result of ground settlement.

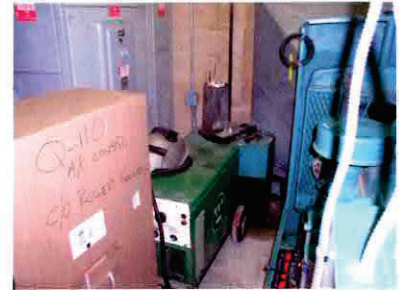
A portable welder is located within the electrical room and is stored between the main distribution panel and emergency generator. The welder should be removed and relocated into another room.

The main electrical room is adequately sized for the equipment. Over time additional items have been added to the room such as an air compressor and a welder. The two pieces of equipment impede proper access to the electrical distribution system and diesel fired generator and create a tripping hazard. The welder and air compressor need to be removed from the electrical room.

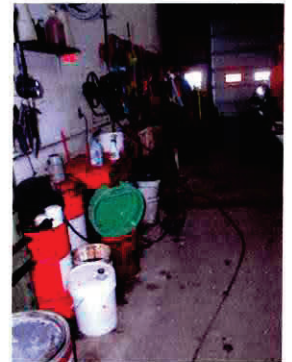
The motor oil tanks located in the garage area should be protected from vehicle impact by the installation of bollards. The potential exists for a vehicle to come in contact with one of the tanks and either knock it over or rupture the side, spilling oil all over the floor. However, the installation of bollards will further restrict the use of the bay.

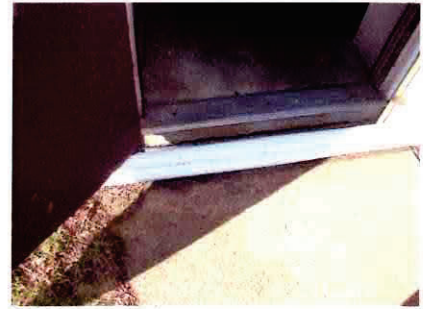
The existing heating and ventilation systems within the building appears to be part of the original construction with the exception of the fuel oil tank. A new above ground fuel oil tank was installed a few years ago. The boiler supply and return lines run along the outside of the building from the tank to the boiler. The lines are insulated to prevent oil from gelling during severe cold spells. The mechanical room has an exterior door and the oil lines run under the door. This is a tripping hazard and is also subject to damaging the piping system. The piping is required to be protected from physical damage.

Replacement of the heating system should be planned in the very near future. The boiler has been repaired on several occasions over the years. There also had been complaints of uneven heating within the building.

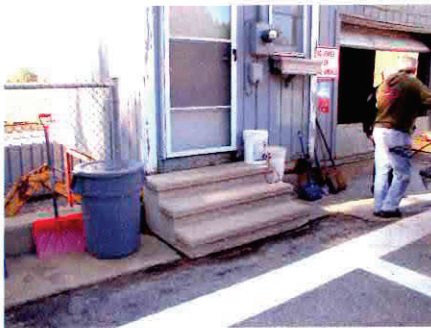
The building is of wood framed construction and only suitable for use by one person. The building allows the attendant to observe what items are being disposed of into the compactor.

Access and egress from the building is a safety issue. The building has a storm door that swings out over the stairs. The state building code does not allow a door to swing over stairs. In addition to the door swing, no landing is present at the top of the stairs, no guardrails, and no handrails. Proper landings, guardrails and handrails are required. The structure is exempt from all accessibility requirements of the state building code due to its size and function.
