**TOWN OF HEBRON
MUNICIPAL FACILITIES STUDY**

**FINAL DRAFT
JUNE 24, 2010**

Executive Summary

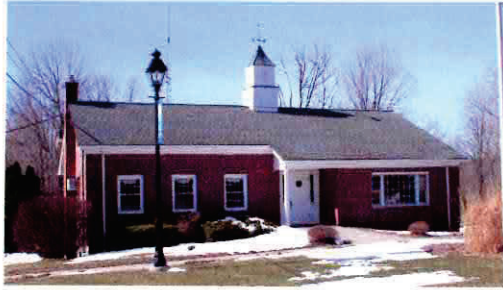
1.1 Town Office Building (15 Gilead Street)

Approximately a third of the roof shingles were replaced in 2009 due to deterioration. This replacement was necessary as part of the elevator addition. The remainder of the roof shingles are scheduled for replacement in the 2010/2011 fiscal year.

The attic area has both fiberglass batt insulation and blown insulation. The blown insulation is disturbed in many areas allowing heat and conditioned air to escape the building. The blown insulation should be evenly distributed and the installation of R-19 un-faced fiberglass insulation over the entire attic area. This method would help prevent the blown insulation from being disturbed and will also increase the energy efficiency of the building resulting in lower utility costs.

The interior stairway was originally construction as part of the 1982 addition. The stair is used on a daily basis by both staff and the public that visit the building. The stair treads have an aluminum nosing and have become worn and are in need of replacement. When this nosing gets wets it becomes slippery. The replacement of the aluminum nosings and finishes is recommended to eliminate this slippery condition.

The 1982 addition incorporated a passive wall panel system to capture the warmth from the southern exposure. This system has long been abandoned. The current glazing is still present as seen in the photo to the right. Over time the seals on the glazing have failed and the vents that lead into the building have been sealed off. Also several of the panels have been vandalized. The panels should be removed and the openings in-filled.

It has been observed when it is raining, water from the roof overflows the gutter and is creating a trough on the ground along the building. This is caused by debris in the gutters and downspouts being clogged. The debris is mainly caused by leaves from the trees to the West. To prevent further ground erosion, maintenance costs and to extend the life of the roof, gutter guards should be installed. This will allow debris to fall off of the roof and reduce the maintenance cost associated with cleaning the gutters and repairing the ground.

The concrete foundation wall on the original building has been repaired over the years. The outside corners of the foundation have spalling concrete and the chimney has separated from the building. The cause of the cracking is not known and this condition should be monitored to determine if it is still moving or the separation was a result of ground settlement.
